P 0 6/82	P1 687	INVENT	ORY	Pacific No	tional Park Service cific Northwest Region tural Resources Division				1 Sixt	er.	1920 on 98121	
2 NAME(S) OF STRUCTURE		5. ORIGINAL USE	7. CLASS	IFICATION						T	3	9. RATING
Tipsoo Lake Con	nfort Station	Comfort Station									1,	O, DATE
3 SITE ADDRESS (STREET & NO)		6. PRESENT USE										1933-34
Tipsoo Lake 0-0	060	Same	8. UTM	ONE EAST	ING		NORTH	ING			Ţ,	1. REGION

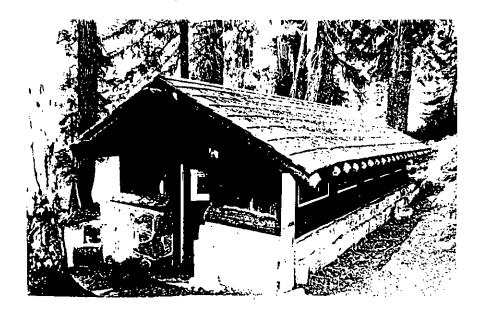
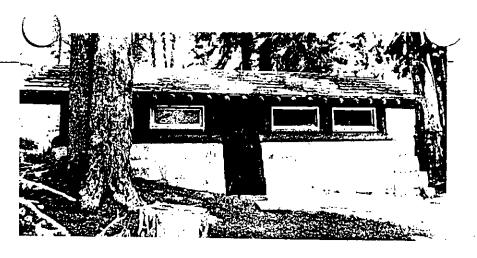
station. Condition of the building is good except for a missing log beam-purlin on side facade that supports eave-roof slope. A log post has been inserted at one gable-verge end to provide roof support.
